SCAAI-1400/2011-EPWA-SP-LPC (rev.1)

Accident Description

Status: **Preliminary Report (rev.1)**

Type: **Boeing B-767-300**

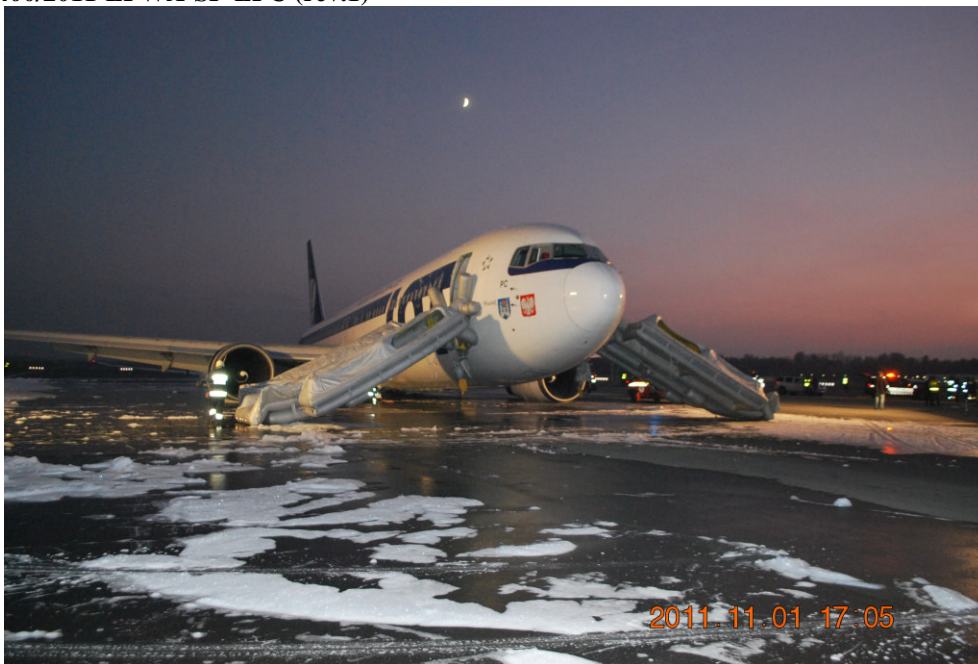
Photo1. General view of SP-LPC after emergency landing.

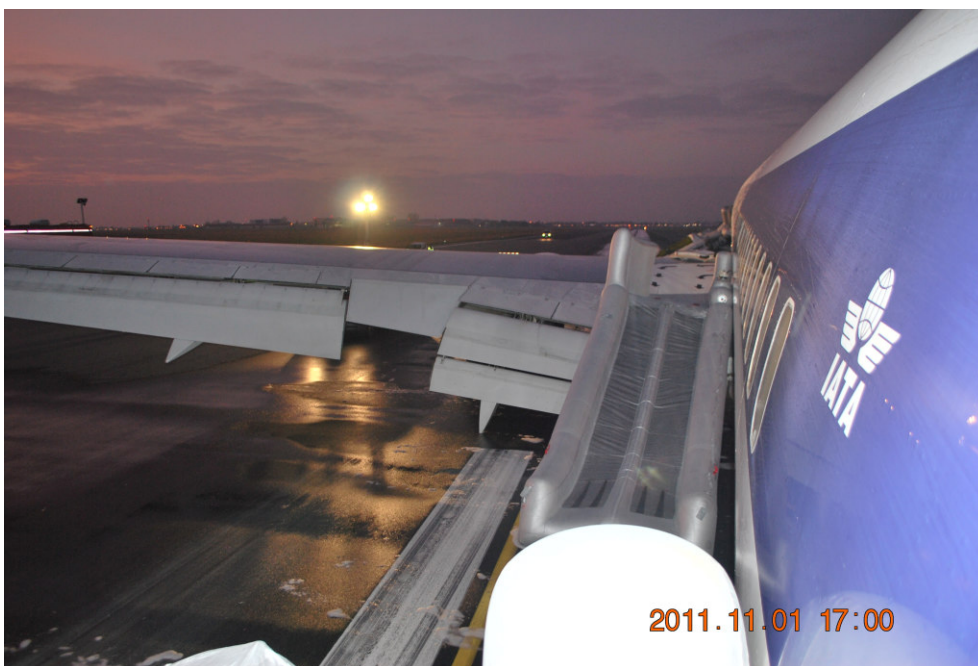
Photo 2. View on the left wing of the airplane from the rear main door.

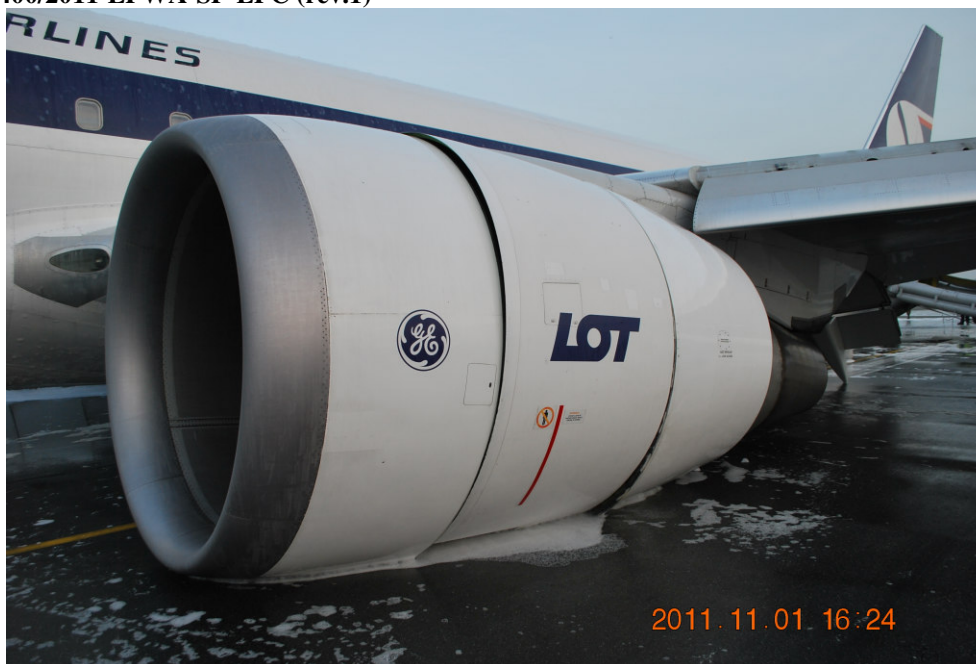
Photo 3. Left engine of SP-LPC airplane

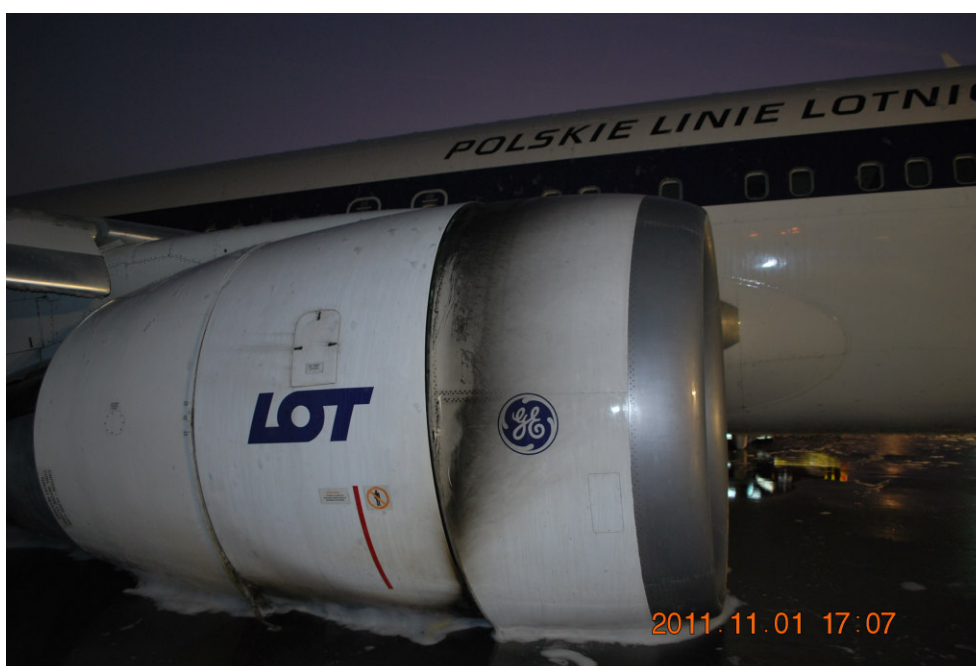
Photo 4. Right engine of SP-LPC airplane.

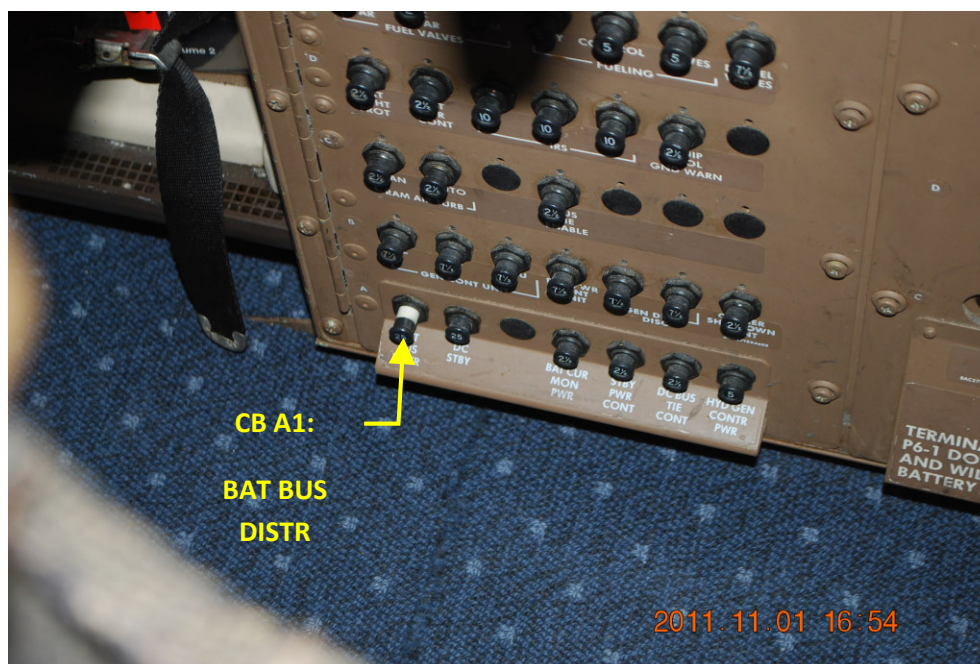
Members of the State Commission on Aircraft Accident Investigation arrived at the aerodrome about 15-20 minutes after the evacuation of passengers and crew. They carried out the initial inspection of the aircraft and found that in the cockpit, on P6 panel, the circuit breaker C829 BAT BUS DISTR (on A1 position) was in the position „Off”, while the circuit

breaker C4248 LANDING GEAR - ALTN EXT MOTOR (on F6 position) was in the position „On”. Records of on-board recorders (CVR - Cockpit Voice Recorder, FDR - Flight Data Recorder and QAR - Quick Access Recorder) were protected and photographic documentation was made.

Photo 5. P6-1 circuit breakers panel in the cockpit.

The circuit breaker C829 (BAT BUS DISTR) indicated on Photo 5 protects several airplane systems including the alternate landing gear extension system. The „Off” position of the circuit breaker was not recorded or indicated by the airplane systems (FDR - Flight Data Recorder and EICAS - Engine Indications and Crew Alerting System).

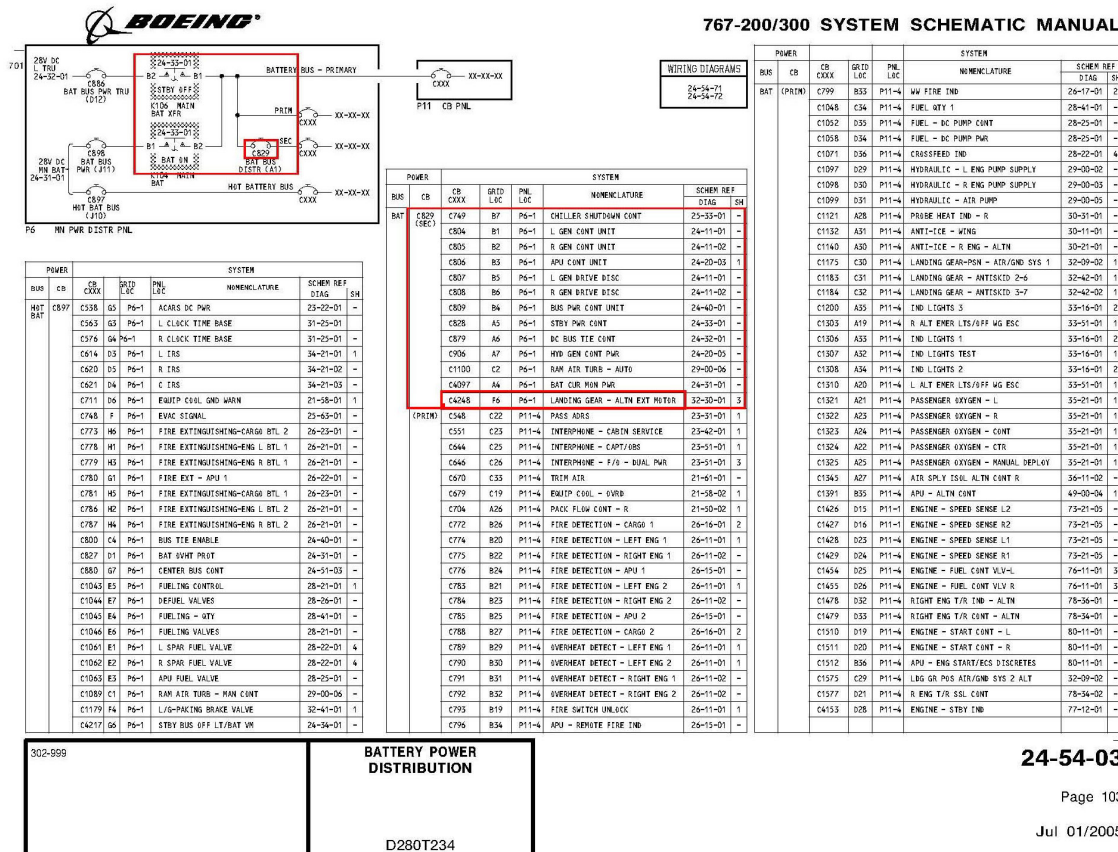
The electrical systems connected with C829 (A1) „BAT BUS DISTR” circuit breaker

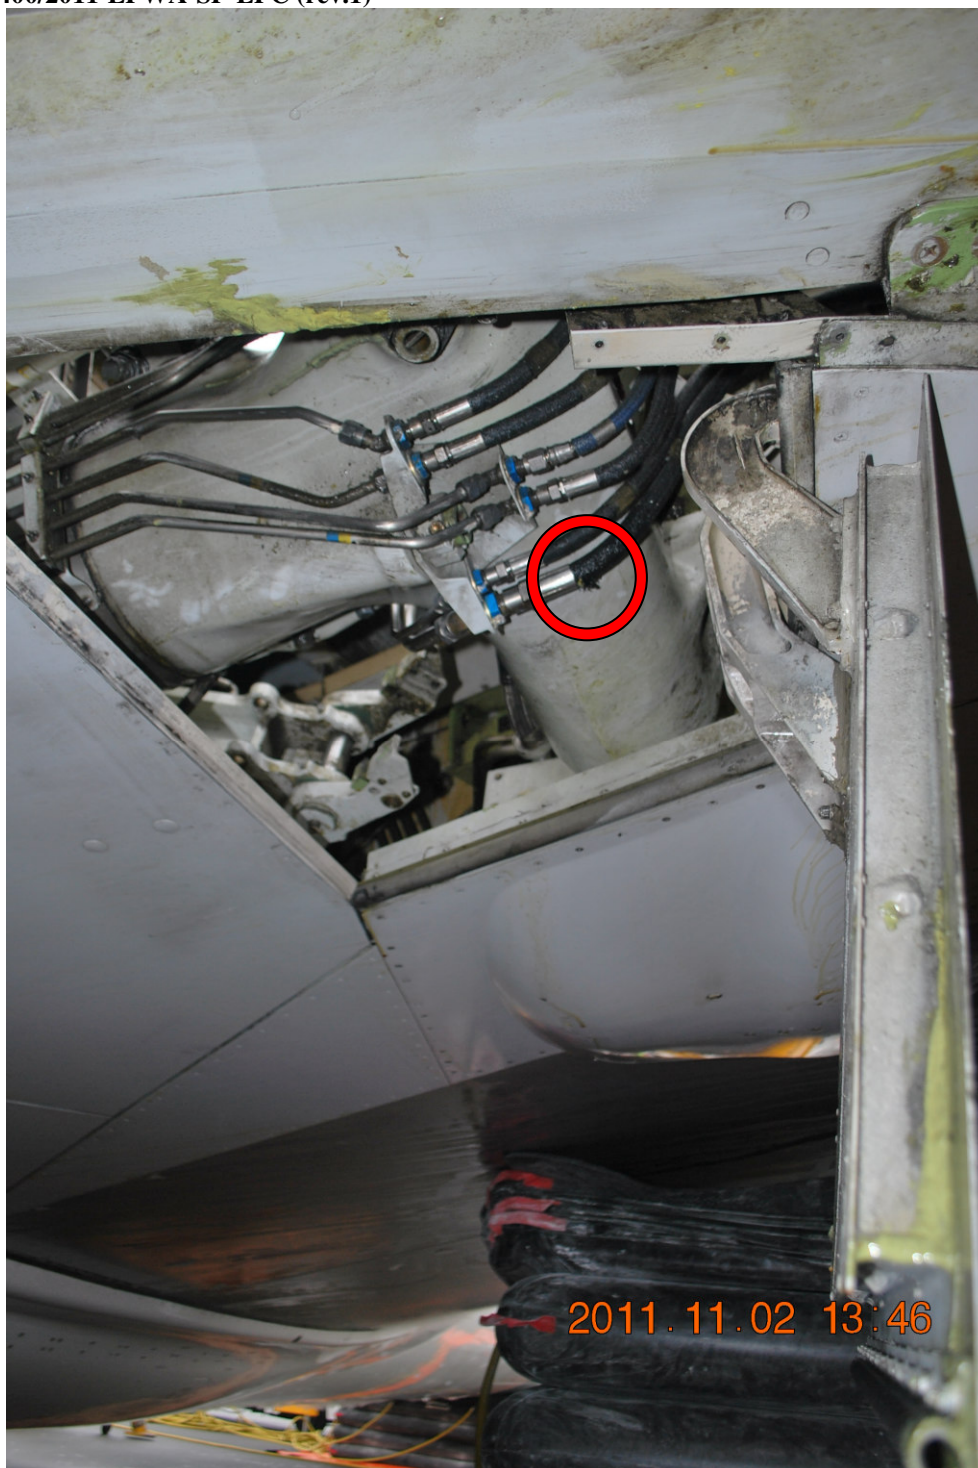
On 2 November the place of hydraulic fluid leakage was identified (see Photo 7 and 8).

Photo 7. View of the hydraulic hoses of the right main landing gear of SP-LPC airplane

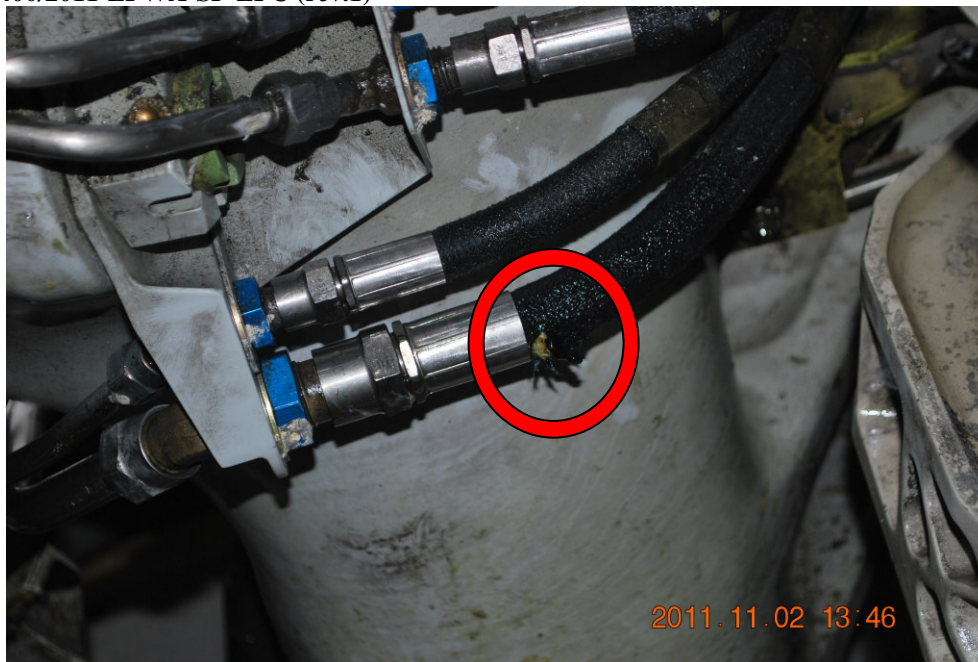
Photo 8. Damaged hydraulic hose of the right main landing gear of SP-LPC airplane.

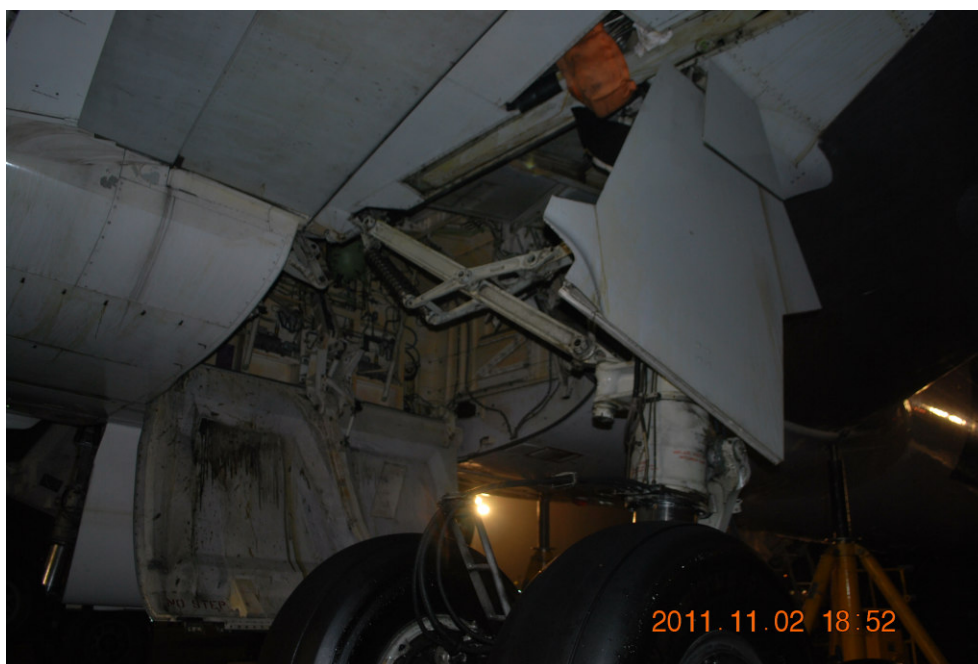
After lifting the aircraft from the runway, in agreement with this operation manager, a test of the landing gear extension with the alternate landing gear extension system was carried out. After connecting the ground power unit, setting C829 (A1) BAT BUS DISTR circuit breaker in the position „On” and activation of the alternate landing gear extension system, the landing gear was extended. The aircraft was towed to the operator's technical base.

Photo 11. Extended right main landing gear after lifting SP-LPC airplane.

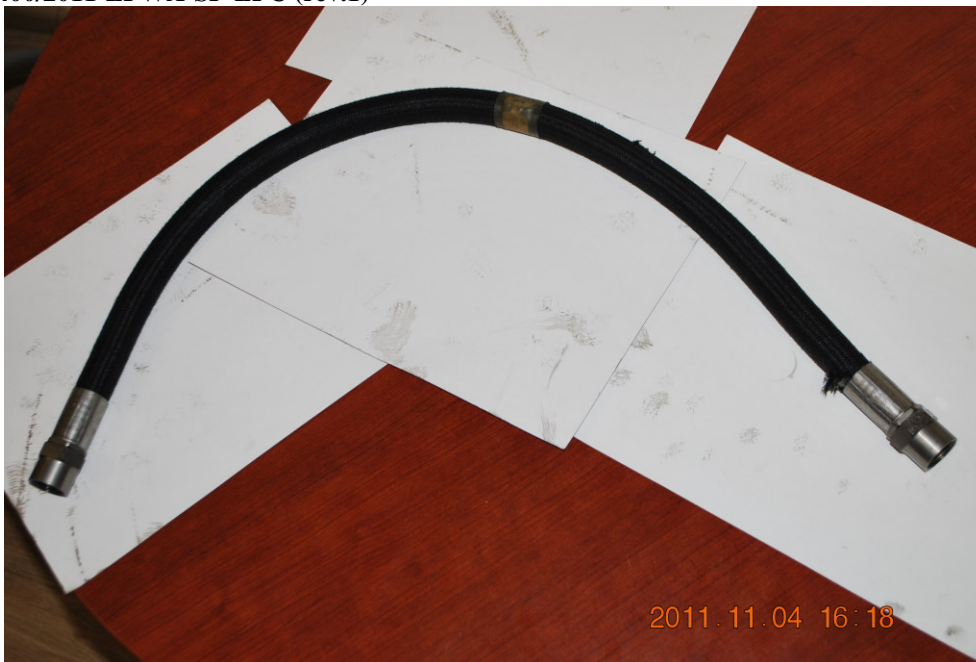
On 4 November members of SCAAI Investigating Team participated in disassembly of the damaged hose of the hydraulic system „C” (central) and secured the hose to carry out tests. The hydraulic hose together with photographic documentation was sent to the laboratory of National Transportation Safety Board (NTSB).

Photo13. Damaged hydraulic hose of the landing gear extension system of SP-LPC airplane.

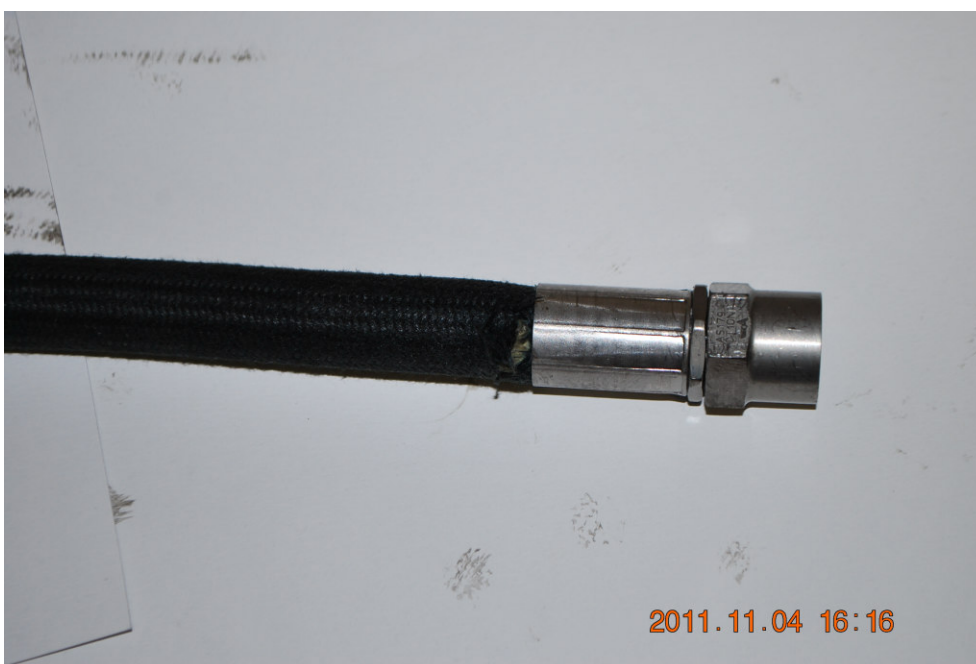
Photo14. Damage to the hydraulic hose of the landing gear extension system of SP-LPC airplane.

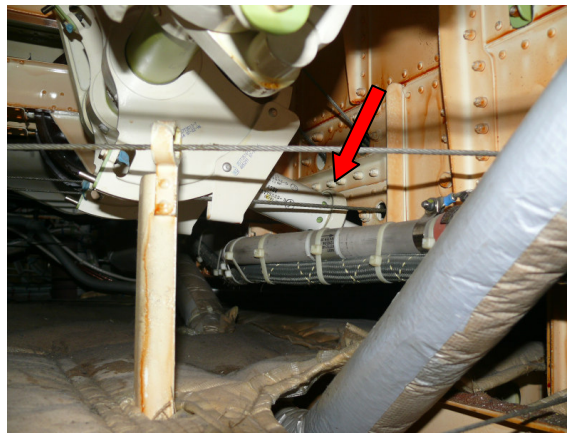
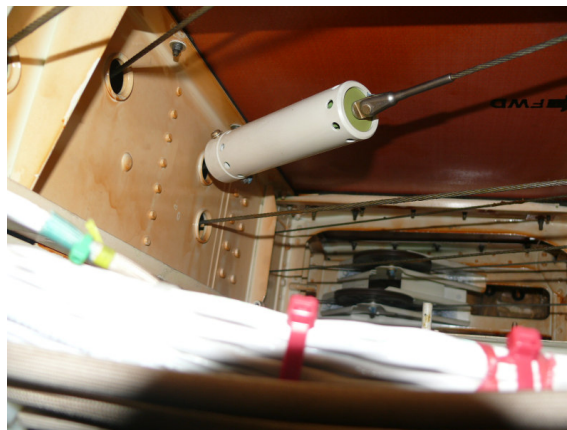
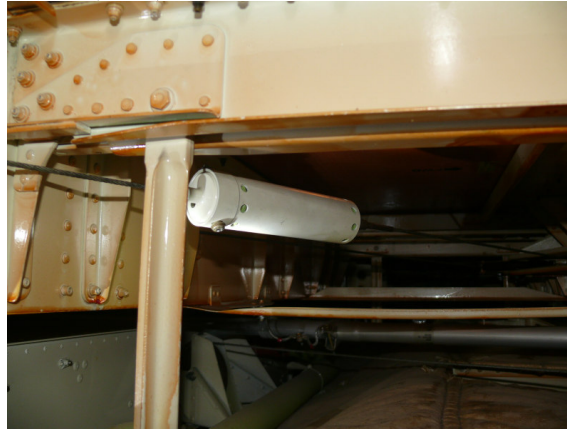
Visual inspection of individual elements of the alternative system of landing gear extension was made. Condition of all load limiters (indicators) of this system did not raise any objections (NLG / MLG LOAD limiters).

Photo 15. Load Limiter of the nose alternate landing gear extension system.

Photo 16. Load Limiter of the main left alternate landing gear extension system.

Photo 17. Load Limiter of the main right alternate landing gear extension system.

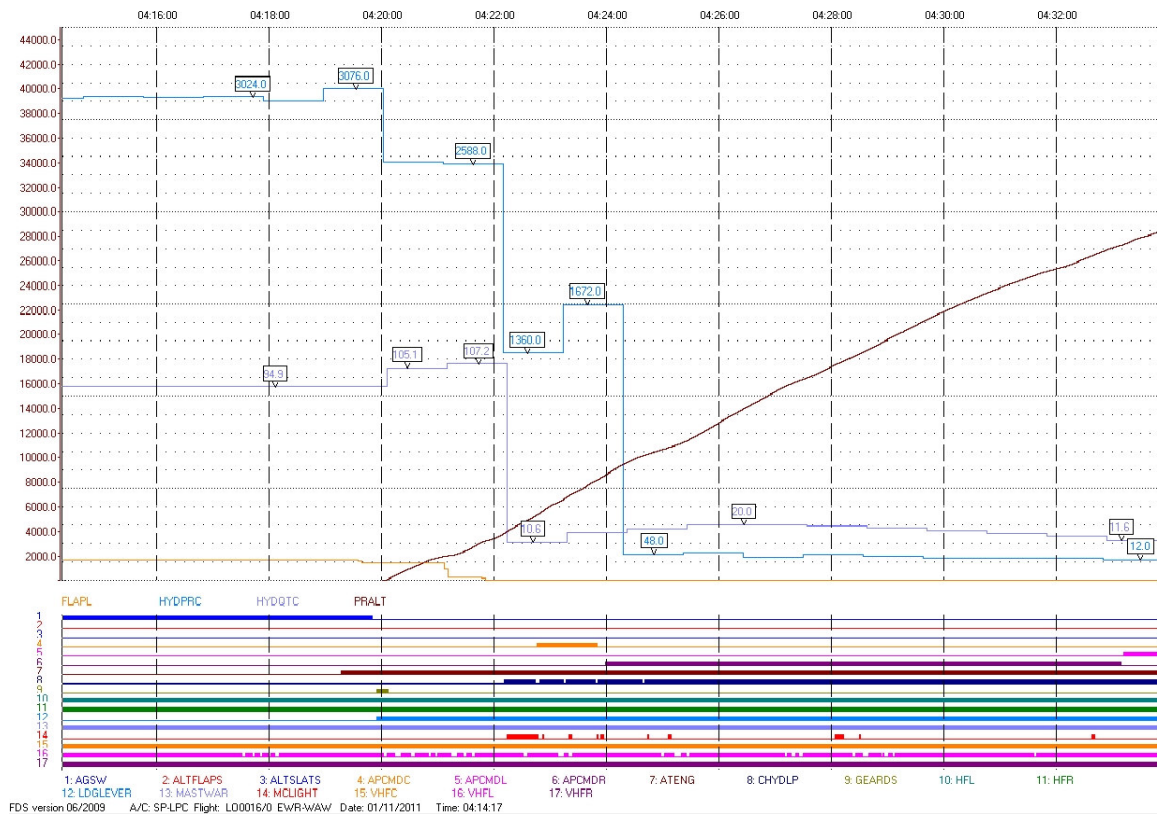
04:21:51 – flaps in position 0,
04:22:11 – indication of low pressure in the central hydraulic system, PRALT=3852[ft], gross weight of the airplane GW=162,57[t], geographical coordinates: N40 48 42, W74 5 17

04:22:14 – drop of hydraulic fluid quantity in hydraulic system „C”, HYD QTC =10.6 [%] (parameter registered in interval 1/64Hz)
04:36:28 – cruise altitude FL310,

Pressure drop in SP-LPC central hydraulic system after take off – based on FDR recording
